Case 308 : Narrative

Case Vehicle (A): 1999 Pontiac	Veh. (B): 1986 Ford
Type: Montana, AWD minivan	Type: F-250, 4 x 4, pickup
Driver: 45-year-old male	Driver: 49-year-old male
CDC: 12-FDEW-6	CDC: 11-FDEW-2

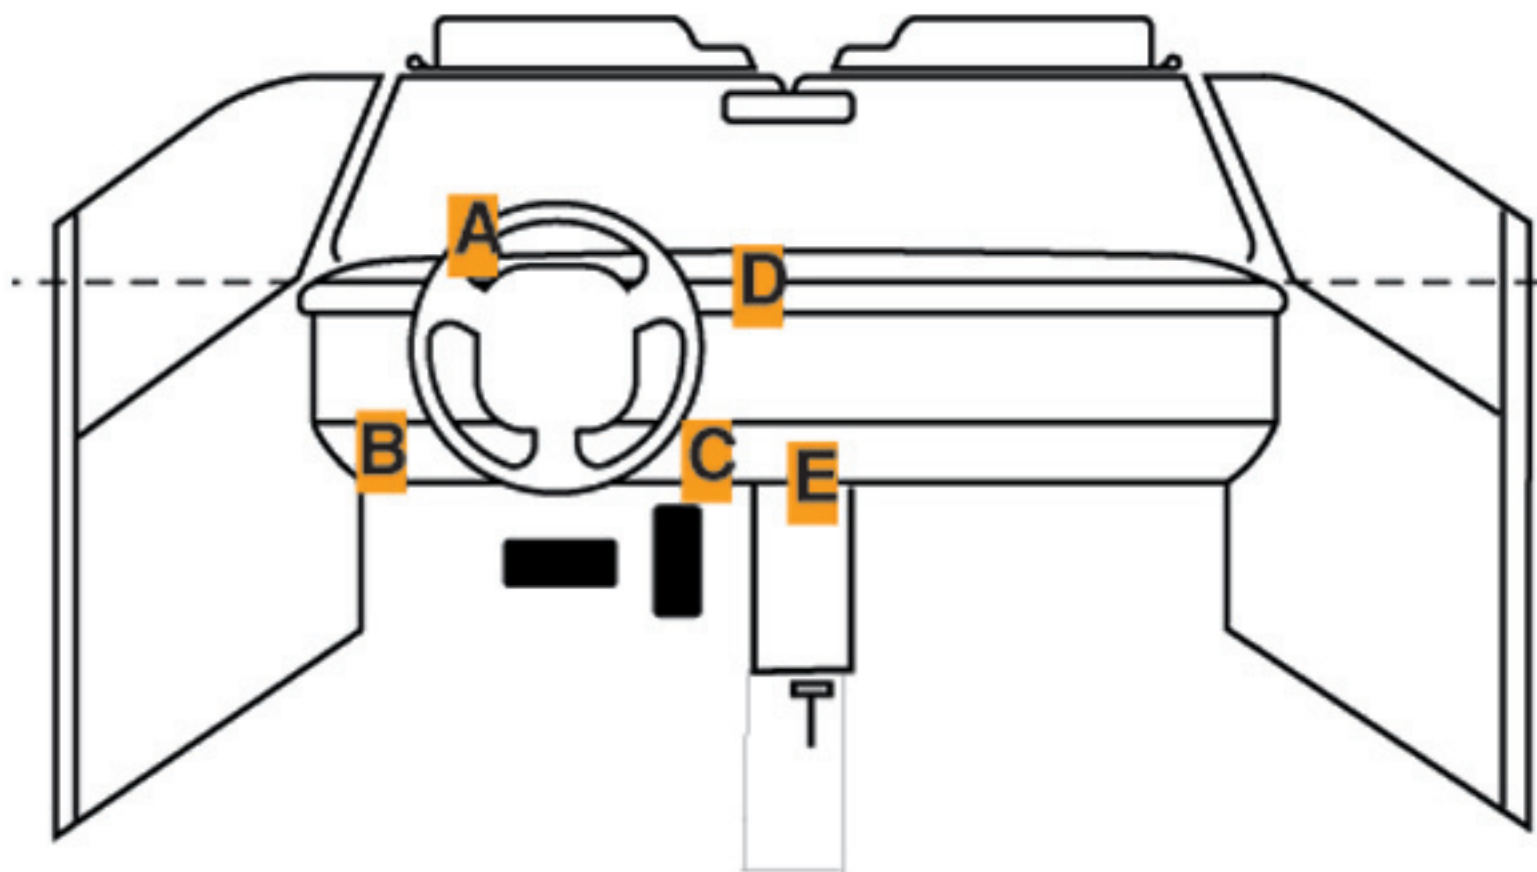
OCCUPANT CONTACT WORKSHEET

- A. steering-wheel rim = scuffed and bent
- B. knee bolster = scuffed
- C. knee bolster/vertical console junction = indentation
- D. upper instrument panel = scuffed
- E. vertical console = scuffed, broken and cloth transfers on heater controls
